**Final Report**

**A Comprehensive Approach to Reservoir Habitat Management in  
Table Rock Lake**

***Missouri Department of Conservation***

**June 12, 2014**

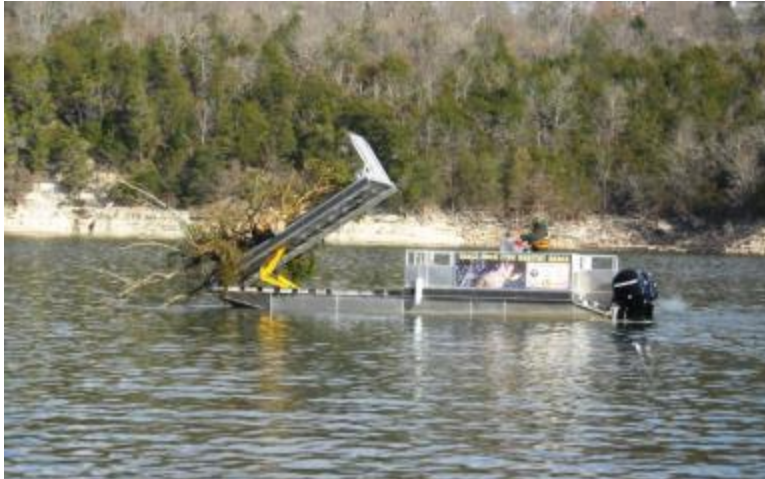
This barge was transported on a heavy duty boat trailer which was pulled by a 1¾ ton truck (Ford F-550, 6.8 L V-10). This barge could be loaded into the water at all of the surrounding USACE boat ramps and most of the private ramps around the lake.

Figure 1.1: Table Rock Lake fish habitat barge.

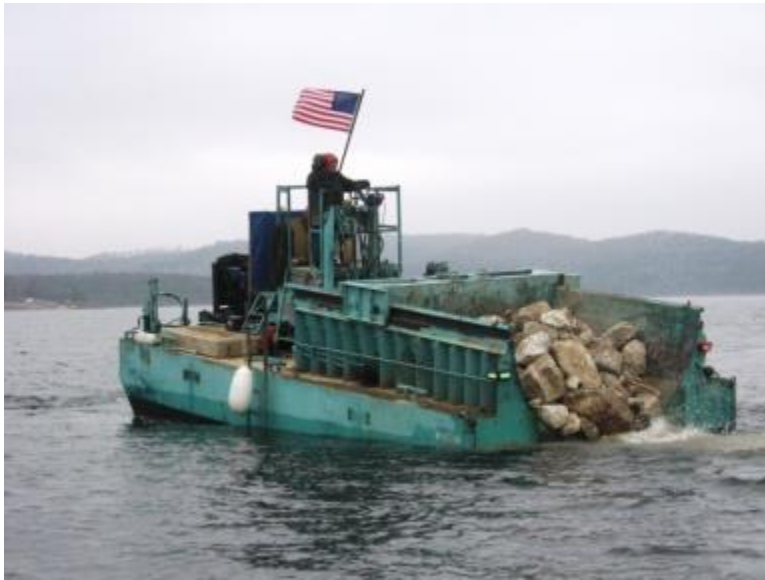
of the barge. This design greatly increased stability with larger loads since the load was never raised from the level it was placed.

Figure 1.2: ECS Midwest's "Hammerhead" rock barge.

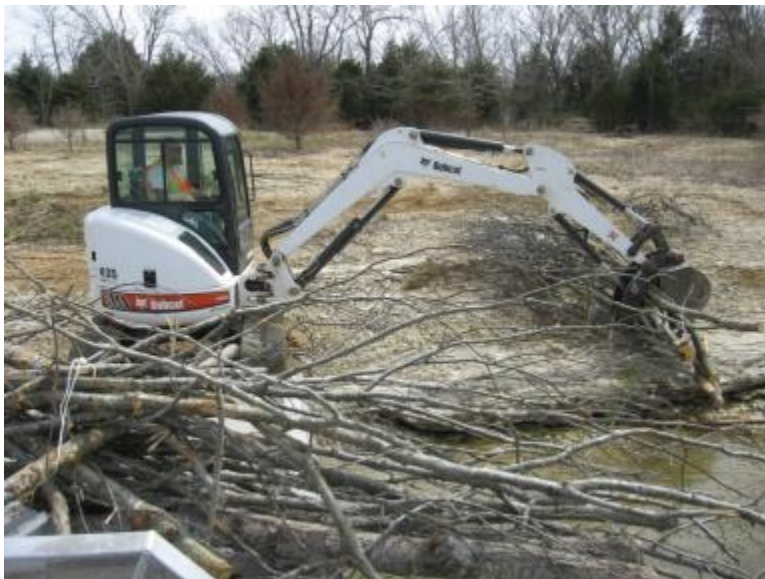
Multiple excavation machines were used for placing habitat on the barges, organizing materials at staging sites and cleaning areas where habitat projects had been completed. Most of the materials were lifted onto the barges with track-hoe type, excavation machines. The hardwood and cedar materials were loaded onto the MDC habitat barge using a 50-class, 10,000 pound capacity excavator with a hydraulic thumb attachment (Figure 1.3).

Figure 1.3: 50-class, 10,000 pound excavator handling trees to load onto the Table Rock Lake habitat barge.

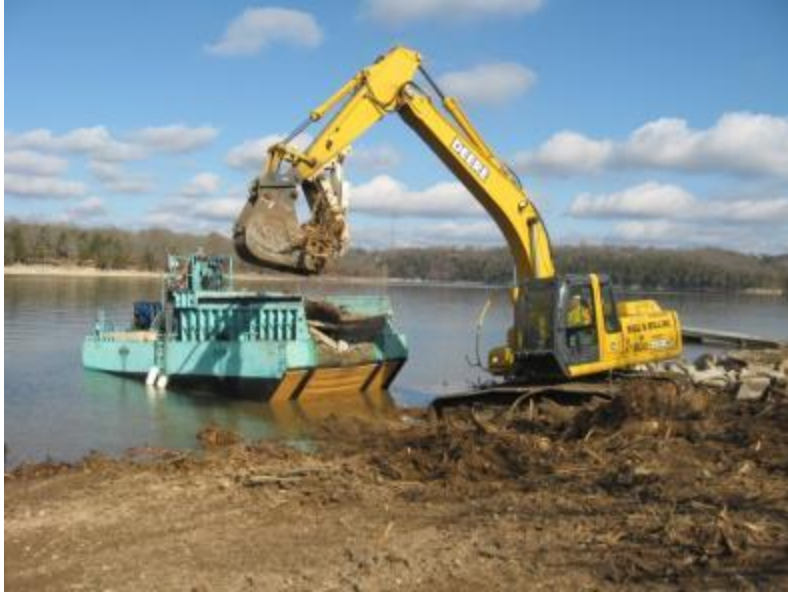
minimal disturbance to the vegetation, landscape and other area aesthetics. The larger stumps and rock materials were moved and placed onto the rock barge with a 200 class, 45,000 pound capacity excavator with a stationary thumb attachment (Figure 1.4).

Figure 1.4: 200-class, 45,000 pound excavator loading stumps onto the rock barge.

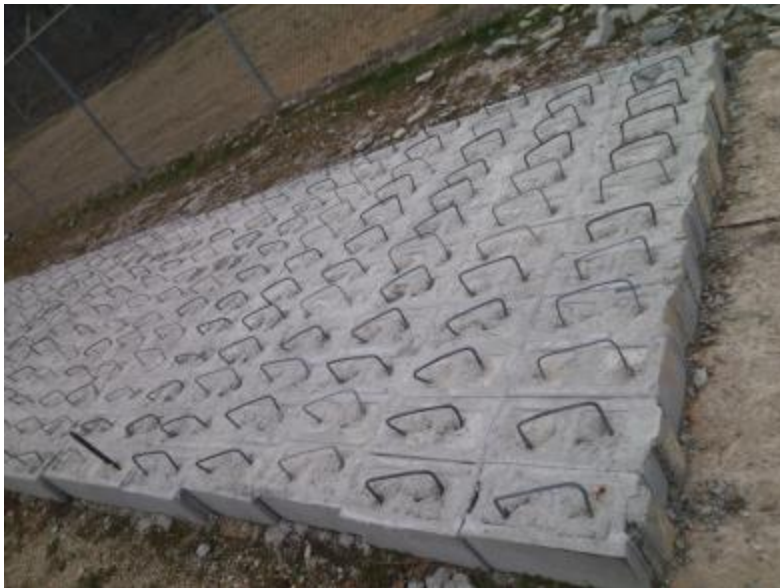
does not negatively impact water quality. Concrete is also readily available and easily manipulated prior to curing. Initial anchors were created using five gallon buckets. Concrete was poured into the buckets using a concrete mixing truck. These anchors varied in size and weight as a standard amount of concrete could not be established. This method also required a large crew and was very slow. Also, the buckets had to be washed with some form of release agent (diesel fuel) that would allow the concrete to be removed from the buckets after curing. The average weight for an anchor created in this manner was between 30 and 40 pounds, but varied from approximately 15 pounds to nearly 70 pounds. A method of creating anchors in more efficient manner and standardizing size was needed. Standard 8" X 8" X 16" cinder blocks were used as forms to create these anchors. The cinder blocks were laid out on a flat surface, with all edges touching another block and the hollow portions facing upward. Concrete was then delivered by truck and poured onto the "field" of blocks. When all of the hollow areas of the blocks were filled with concrete, anchor handles were placed in the wet concrete (Figure 1.5). These anchors weighed between 75 and 80 pounds.

Figure 1.5: Field of finished anchors.

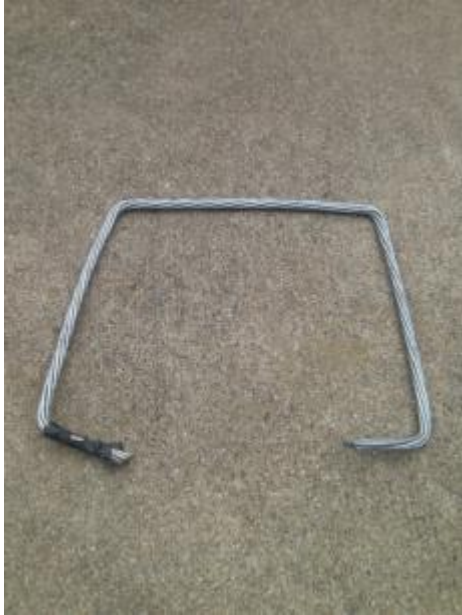
repaired, the stabilizing guy wire would be replaced and discarded. Personnel at WRVEC placed a pallet near the disposal area to load guy wire to be used on the NFHI project. The wire was then cut into 30” sections and bent into a “C” (Figure 1.6) to be placed into the anchors.

Figure 1.6: Guy wire formed to be placed in wet concrete of anchors to create an anchor handle.

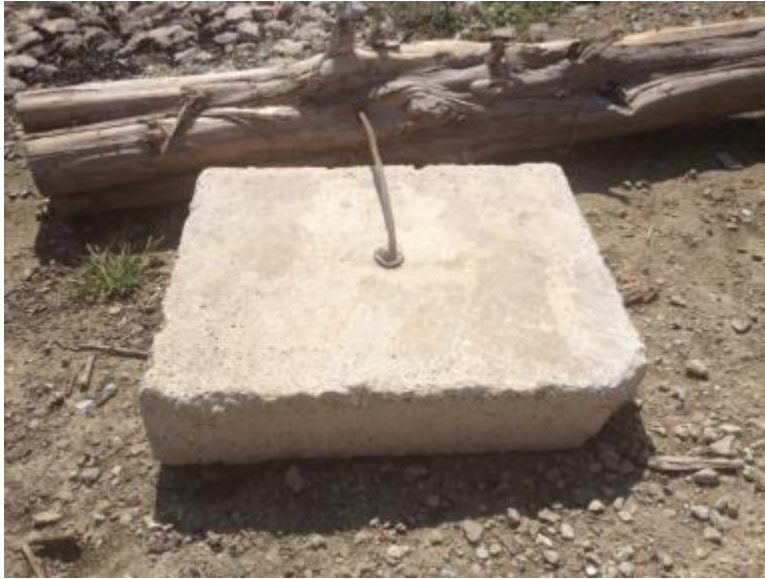
Another type of anchor used for this project was built by the hauling and loading contractor. These anchors were also made of concrete, but were much larger (>200 pounds) therefore requiring machinery to move them. A concrete form measuring 18” X 18” X 8” was used to build the anchors. The anchors were built with a central hole created by inserting a PVC pipe into the form before pouring the concrete. These anchors were then tethered to the materials using twisted, stainless steel cable and bolted cable clamps (Figure 1.7).

Figure 1.7: Larger concrete anchor made by contractors.

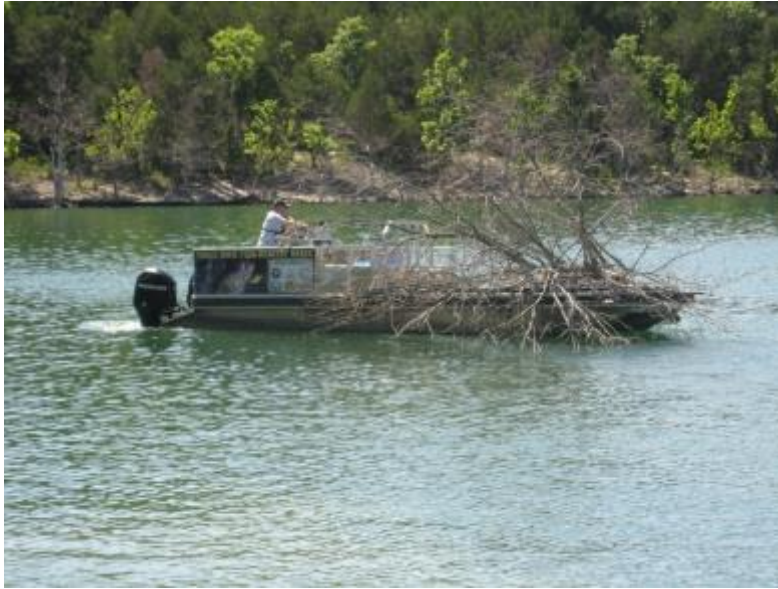
A majority of the habitat that was used for the NFHI project was in the form of hardwood tree tops (Figure 1.8). The forests of the Ozark highlands in Missouri are composed primarily of oak and hickory (Fagaceae and Juglandaceae) trees. The typical types of hardwood trees obtained for habitat were red and white oaks (*Quercus* spp.), hickory (*Carya* spp.), elm (*Ulmus* spp.), and maple (*Acer* spp.). Landowners and developers who chose to clear timber or selectively log areas of land could donate the tops of the trees to MDC. Hardwood tree tops are not marketable and are normally discarded during logging and clearing operations. During clearing, trees were taken down by any means the landowner decided, at their expense. The tops of the trees were removed by the contractor and taken to a staging area, where they could be prepared for placement into Table Rock Lake. A 10,000-pound class excavator was used to consolidate the habitat material and allow MDC personnel to tie anchors to the material. Once the anchors were tied to the materials, the excavator then loaded the materials onto the habitat barge to be transported to habitat placement locations on Table Rock Lake.

Figure 1.8: Table Rock Lake habitat barge with hardwood trees.

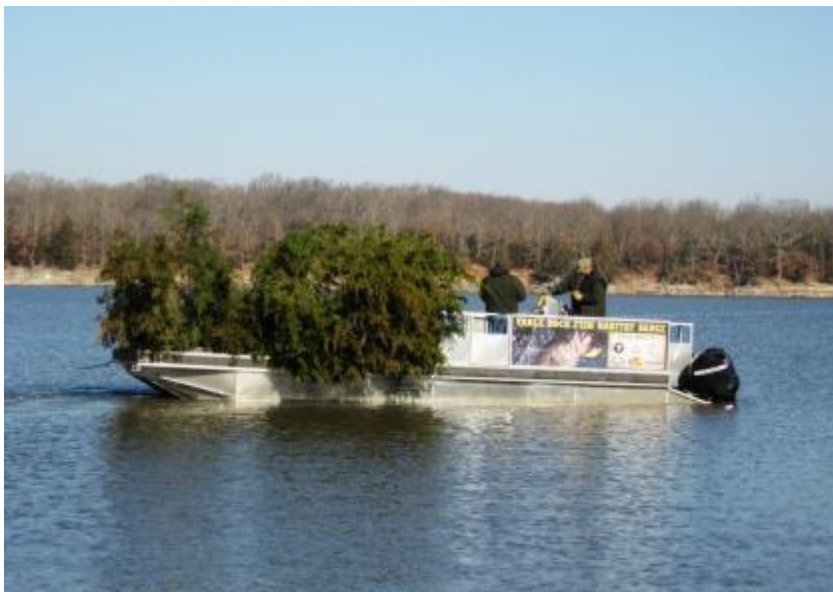
Cedar trees are very abundant in the Table Rock Lake watershed. Much of the Ozark highlands are composed of glades and rock covered hills. These areas provide optimal conditions for cedar tree growth. Cedar trees are a common material type used by fisheries biologists for habitat enhancement projects. Cedar trees can create very large and complex habitat structures with much less weight than a hardwood top of the same size. Landowners, developers and others readily remove these trees for glade restoration and land improvement projects. Transporting and loading of cedar trees was very similar to hardwood tops (Figure 1.9). Contractors reduced the diameter of the cedar trees prior to hauling by using machines to pull the trees through a large pipe and band and compress the trees. This allowed for larger trees to be transported by road without reducing size. The bands were cut to allow the tree to expand to its original size before being placed into the lake. The same type of equipment and process for loading the barge with hardwood tops was used for cedar trees.

Figure 1.9: Table Rock Lake habitat barge with cedar trees.

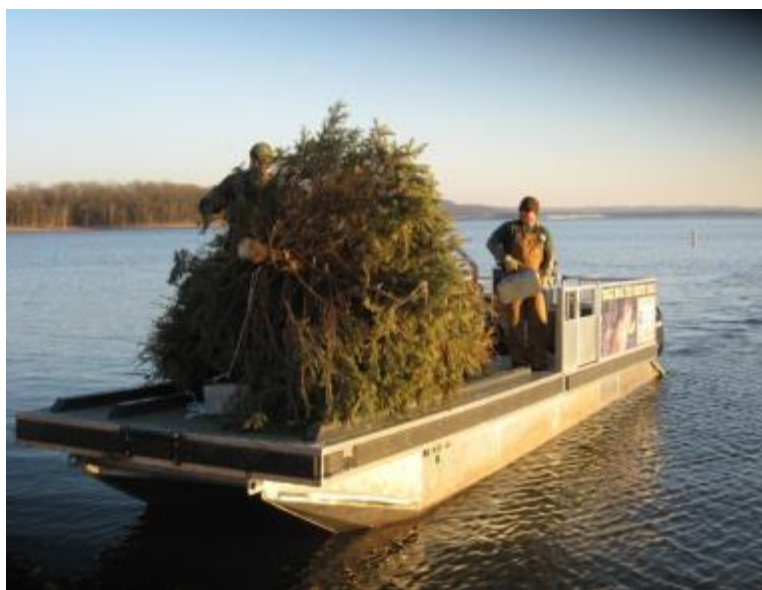
Pine trees, in this context “Christmas trees”, are readily used by a majority of fisheries biologists for habitat enhancement and restoration projects (Figure 1.10). Christmas trees are usually collected at drop off locations, where anyone wishing to discard a used tree may bring it to a specified location and leave it for fisheries biologists to place into a water body for fish habitat. For this project, BPS in Springfield, Missouri, along with The Boy Scouts of America, collected Christmas trees at the BPS store and delivered them to Table Rock Lake by the semi-truck load. Silver Dollar City, a Branson area attraction, also donated Christmas trees and delivered them to nearby areas of the lake. Once collection and delivery was accomplished, the trees were sorted and loaded onto the habitat barge by hand, and placed into Table Rock Lake.

Figure 1.10: Table Rock Lake habitat barge with pine (Christmas) trees.

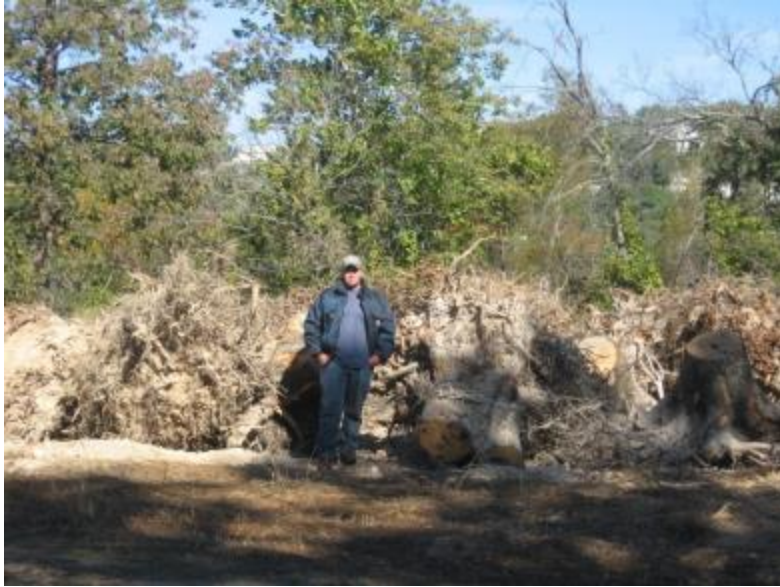
Large stump fields were created using the “rock barge”. These stumps were primarily hardwood stumps including the root ball and substrate material from where the stump was removed (Figure 1.13). The stumps could be small (six inches in diameter) and loaded many at a time, or very large (20”-30” in diameter) to make larger individual structures. The configuration of an individual stump varied from containing just a root ball to having a trunk length of five feet or more. Due to the substantially larger size of the stump structures which projected higher off of the bottom contour, there could be a possibility of stump structures causing navigational hazards to boaters and swimmers. For this reason, MDC and USACE established a minimum depth requirement for placing stump structures. The minimum depth of any structure composed of stumps placed in Table Rock Lake was 10 feet (905 msl) and any stump structure placed in areas of heavy boat traffic would be placed in no less than 20 feet (895 msl). This requirement greatly reduced the chances of these structures creating navigational hazards.

Figure 1.13: Stumps staged on shore before being placed in Table Rock Lake.

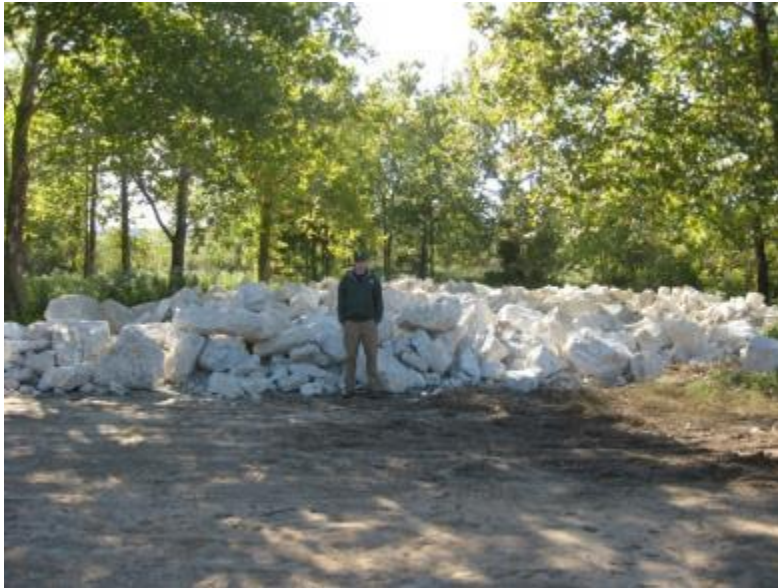
These structures were placed in the same manner as the stump structures and had the same depth requirements. Rocks placed in a line by moving the barge did not extend very high into the water column and were slightly harder to locate using a typical sonar graph. Rock “fence” structures were also created during the NFHI project. These structures were intended to provide a non-degrading, shallow water structure during certain times of the year, especially the spring spawning season. Table Rock Lake’s shoreline consists primarily of large gravel to boulder size rocks with a majority of the substrate consisting of cobble. This type of substrate can be useful for some species of baitfish and crayfish, but gives very little cover for larger species of fishes. Many of the Table Rock Lake fishing guides noted that fish utilize pre-existing rock fence structures as cover during the spring spawn and any other times when fish are located in shallow water.

Figure 1.14: Rocks staged on shore before being placed in Table Rock Lake.

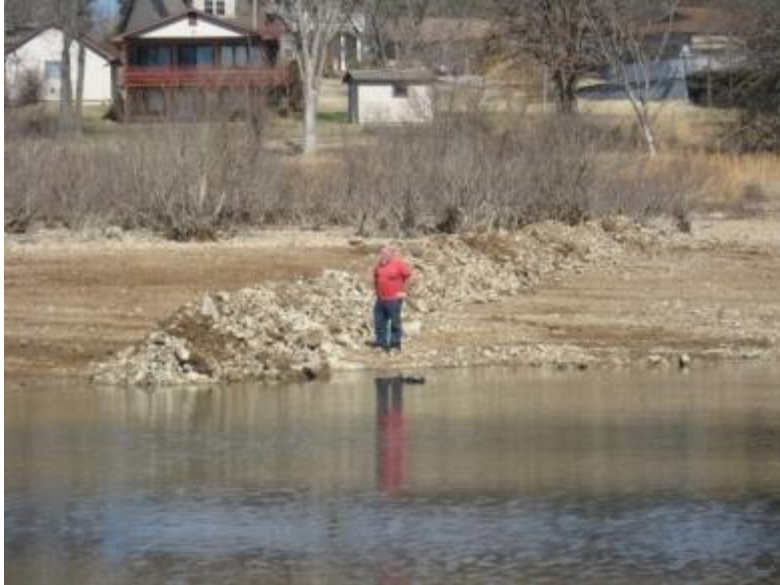
varied in length from 50-100 feet in length and were raised to a height of approximately four feet tall. The length of shoreline that was exposed to useable gravel substrate for the structures varied from 100-300 feet.

Figure 1.15: Complete rock fence structure.

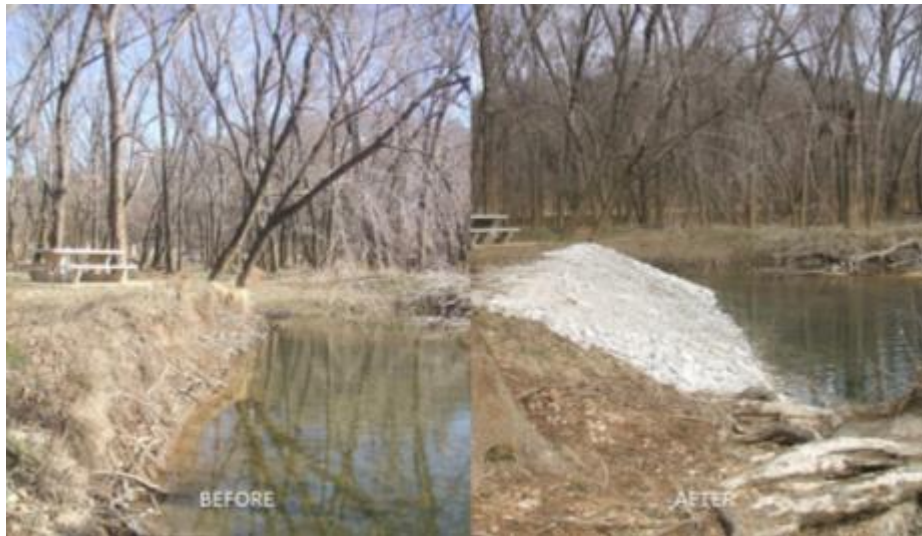
This project was located in Stone County, Missouri. The eroding bank was located at the confluence of the James and Finley rivers. This area had become very unstable due to removal of riparian vegetation. The area had also been routinely mowed and vehicles had been allowed to access areas near the streambank. The streambank of concern was an 80 feet long section of bank (Figure 2.4) that had become vertical and had heights of up to six feet.

The stabilization design for the project was to stabilize the entire 80 feet of streambank with a rock blanket. This type of protection covered the entire length and height of the streambank to eliminate additional streambank erosion. After the rock blanket was installed and the toe of the streambank had been stabilized, riparian corridor plantings began. Corridor plantings extended 100 feet from the shoreline, or as far as needed to connect to existing corridor. This project reduced the amount of sediment being transferred downstream by eliminating the erosion taking place in this area. This project also increased the amount of connectivity of riparian corridor in both the James and Finley rivers.

Figure 2.4: Pictures of streambank before and after completion of stabilization of project 42-54-00.

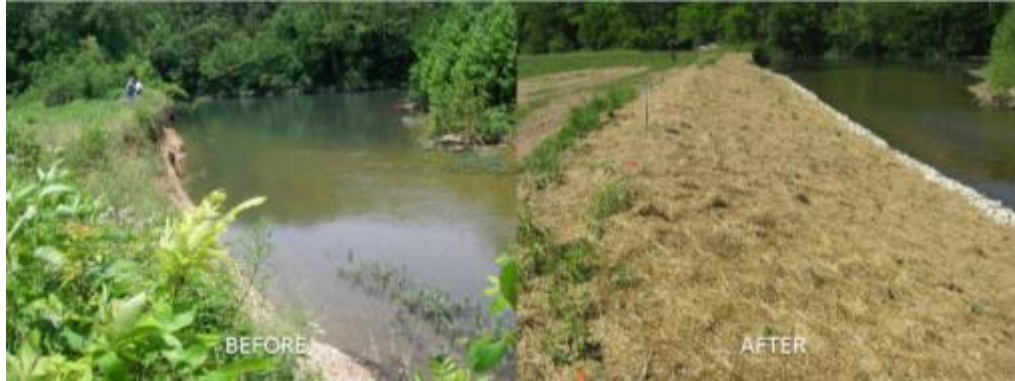
This project was stabilized using longitudinal peak stone toe protection (LPSTP) along the entire eroding streambank as well as two 25' X 6' X 3' bendway weirs to divert the stream channel away from the unstable bank to slow the flow of water that could reach the bank. Once the project was in place, the landowner planted riparian trees and shrubs to increase and repair the riparian corridor in this area.

Figure 2.5: Pictures of streambank before and after completion of stabilization of project 42-54-01.

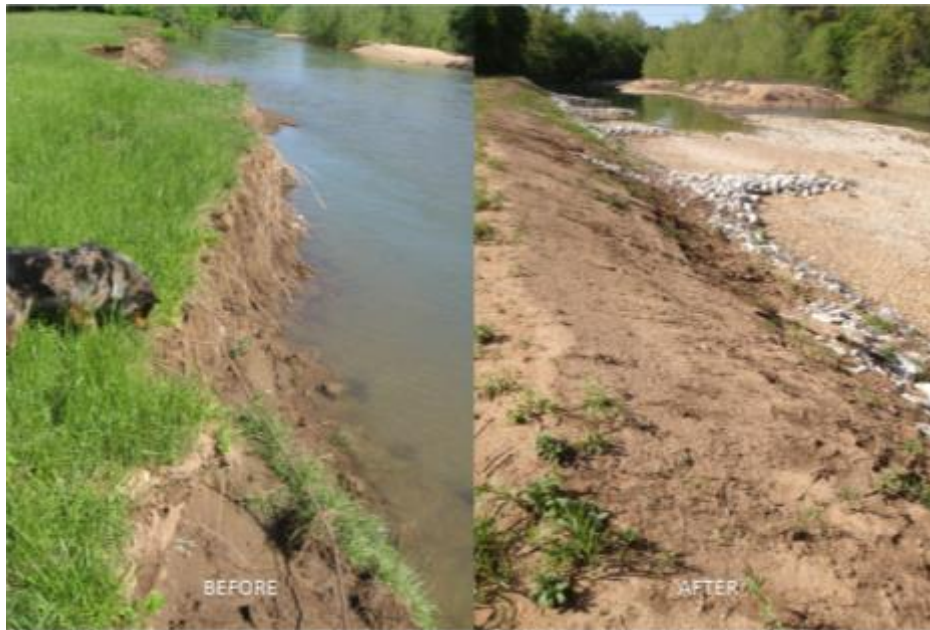
This project was located in Stone County, Missouri on Flat Creek which flows into Table Rock Lake. This bank had become very unstable due to the removal of riparian vegetation suitable to protect the bank from erosion during high flow events. The landowner had experienced accelerated soil loss due to a nearby power line right-of-way that had been treated with herbicide to remove trees, instead of being selectively trimmed. A combination of the loss of bank-holding vegetation and high flow events in 2008 accelerated the bank erosion. The project was 400 feet long (Figure 2.6) and had heights of up to ten feet.

This project was stabilized by creating a rock vane located in front of the streambank to re-direct the flow away from the streambank. Along with the rock vane, four bendway weirs were created to re-direct the flow away from the bank and also reduce the amount of energy from stream flows. LPSTP was installed to stabilize the streambank further. Once the project was complete, the landowner, along with MDC personnel, planted the riparian corridor with a 100 foot buffer of native trees and shrubs behind the stabilization project.

Figure 2.6: Pictures of streambank before and after completion of stabilization of project 42-54-02.

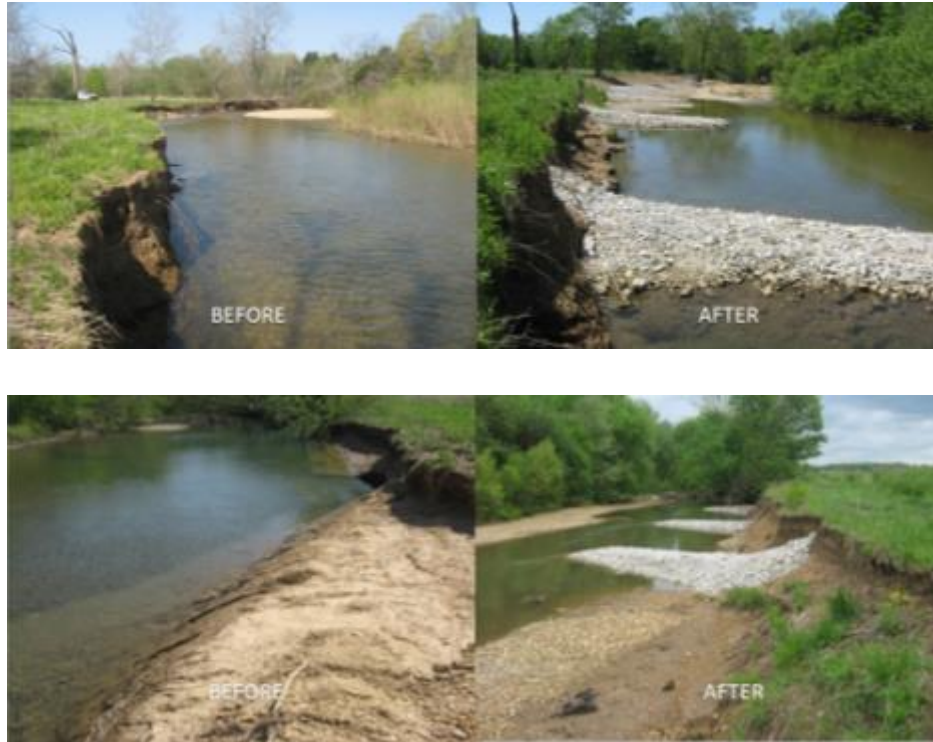
This project was located in Webster County, Missouri in the James River. The landowner had two different streambanks on his property that had experienced accelerated erosion. The landowner had previously attempted to reduce the amount of erosion in the areas by planting a woody riparian corridor. Unfortunately, high flow events in 2008 destroyed the trees before roots suitable to stabilize the bank could become established. The streambanks had a combined length of 950 feet (Figure 2.7) and heights near ten feet.

The lower portion of this project was engineered and stabilized by installing two bendway weirs and one rock vane to direct the flow of the river away from the eroding shoreline and back to the main channel. These engineered structures also collect sediment and gravel along with reducing the intensity of flows during flood events. Along with the engineered rock structures on both

sections of streambank, willow stakes and other riparian trees and shrubs were planted to hold the soils that could experience additional erosion. These additional trees accompanied the existing plantings to form a mixed age riparian corridor.

Figure 2.7: Pictures of streambank before and after completion of stabilization project 42-54-03.

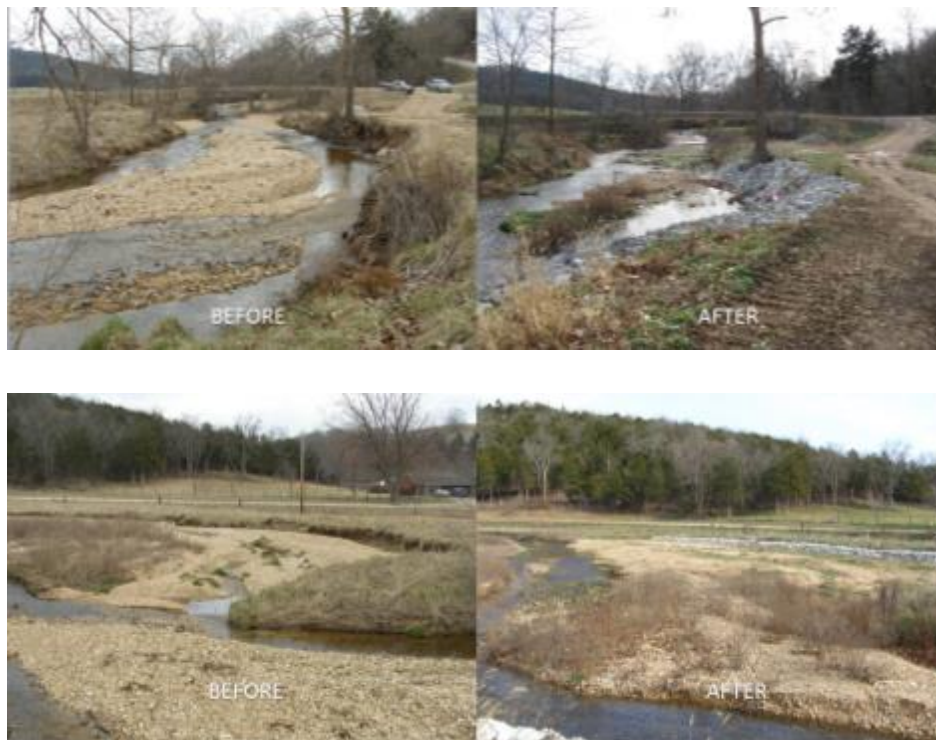
This project was located in Barry County, Missouri on Carney Creek. Carney Creek is a tributary of Flat Creek, which flows into Table Rock Lake. The landowner had attempted to repair his eroding bank by armoring the bank with large boulders and chunks of concrete. After realizing that the methods used were not sufficient, the landowner requested assistance from MDC to determine a better solution to the problem. The unstable streambank was 740 feet long (Figure 2.8) and had heights of approximately three feet. The eroding streambank had become an issue not only with the landowner, but had implications for a power company and the county road department. The electric company had relocated power poles before the erosion caused the loss of the poles and damage to the power lines. The streambank was also becoming an issue to the road department as the eroding bank was causing concern with a road bridge over the creek.

Figure 2.8: Pictures of streambank before and after completion of stabilization project 42-54-04.

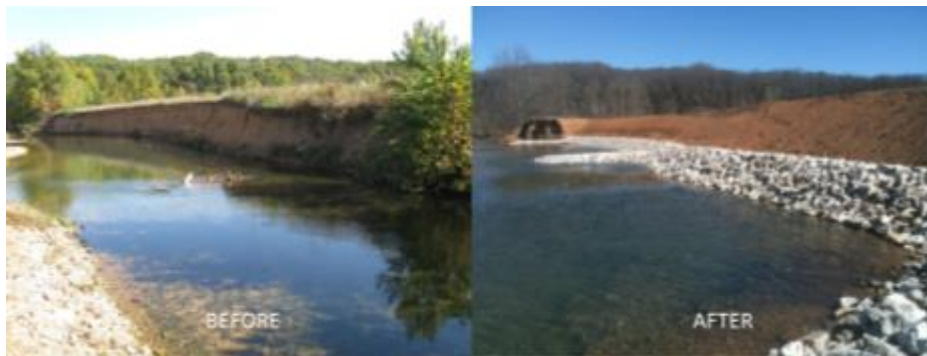
Projects 42-54-09 and 42-54-10 were located in Barry County, Missouri on Flat Creek. These two projects were completed in conjunction with each other as the two landowners had eroding banks directly across the creek from one another. The decision was made to stabilize both banks at the same time as completing one project alone would definitely alter the other bank dramatically. The streambank on project 42-54-09 (Figure 2.9) was very tall (up to 12 feet) and 350 feet long. This streambank was visited by MDC Stream Unit staff in 2007 but was not determined to be eroding at a rapid rate. Significant flooding in 2008 altered the streambank directly across the creek which in turn caused accelerated erosion to occur at this site. The streambank on project 42-54-10 (Figure 2.10) was experiencing accelerated erosion issues before

Figure 2.9: Pictures of streambank before and after completion of stabilization project 42-54-09.

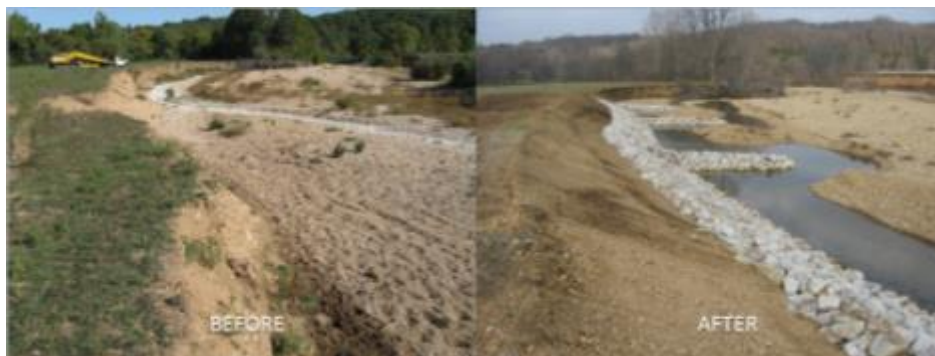
the major floods of 2008. Project 42-54-10 had a length of 450 feet, bank heights of up to 12 feet, and a sharp bend in the bank which was rapidly eroding and pushing flows directly against the adjacent bank, 42-54-09. The riparian corridor of both of these streambanks had been removed for many years, which led to the bank instability. LPSTP and bendway weirs were designed into both projects to reduce flow velocities and protect both banks simultaneously. A large gravel bar had been deposited in the middle of the stream between both projects. The projects were also designed to move the channel away from the streambanks, scour the gravel bar and move the sediment to the sides of the channel near the streambank. Both landowners worked with the Natural Resources Conservation Service to plant 100 foot riparian corridors on both streambanks behind the stabilization projects.

Figure 2.10: Pictures of streambank before and after completion of stabilization project 42-54-10.

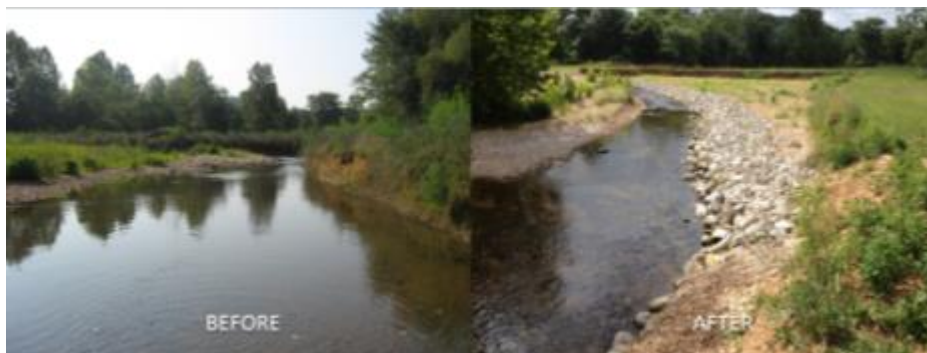
seriously impacted the streambank on this property. Crane Creek is also an MDC Blue Ribbon Trout Area that has a naturally reproducing Rainbow Trout population. Two areas on this property were of concern to the landowner, but only one was determined to be suitable for a stabilization project. This area of the stream had experienced major erosion from high flow events and a lack of riparian vegetation. The stream channel had changed dramatically and created a large “hook” in the bend. The landowner had lost approximately 130 feet of land after the flooding in 2008. This eroded streambank was 400 feet long (Figure 2.11) and had bank heights of six to ten feet.

The landowner had attempted to reduce the erosion by excluding cattle from the area and allowing the vegetation on the streambank to grow. Even with this effort, the streambank was not stable enough to withstand the high flows of 2008. Engineers from MDC surveyed the streambank and determined that the best course of action would be to try and recreate the original streambank utilizing LPSTP, creating baffles behind the channel to dissipate flows and allow sediment to collect before reaching the unstable portion of the streambank. The landowner also worked with MDC to plant a 100-foot riparian buffer of trees and shrubs to help maintain the streambank behind the rock improvements.

Figure 2.11: Pictures of streambank before and after completion of stabilization project 42-54-11.

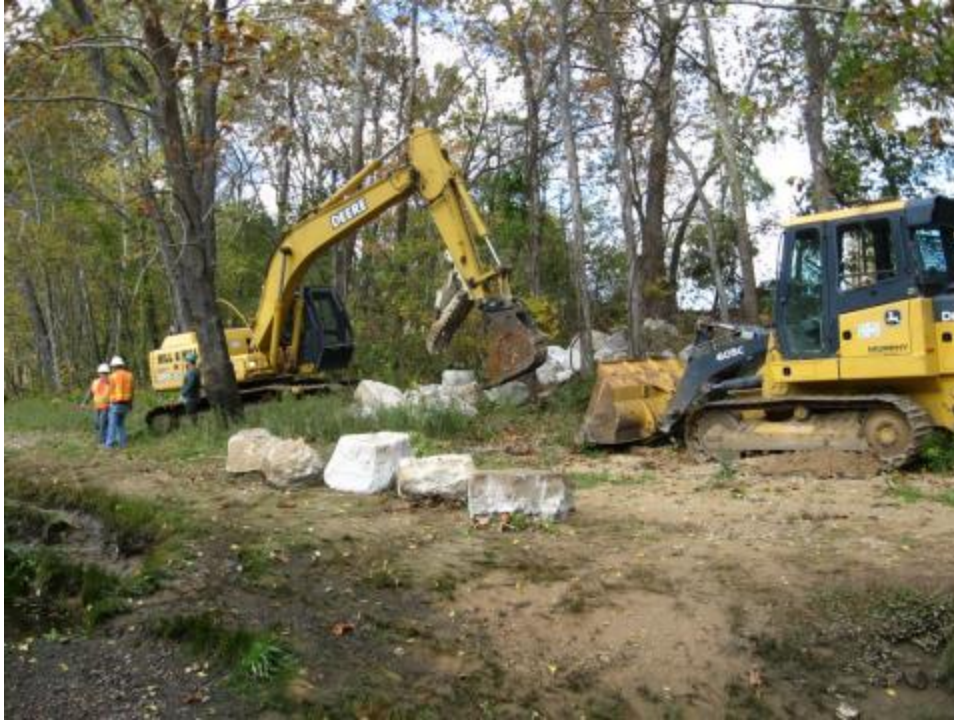
Large boulders and woody structures have been used as trout habitat improvements for many years including recent projects below the Bull Shoals Lake and Beaver Lake Dams in Arkansas. Quinn and Kwak (2000) noted that Rainbow Trout distribution shifted into the modified reaches after habitat structures were installed into the Beaver tailwater. Boulder clusters have historically been effective in increasing the density of salmonid populations, and have been preferred by Brown Trout when compared to single boulders and wingdams (Van Zyll De Jong et al. 1997; Shuler et al. 1994). Boulder clusters placed in areas that remain inundated at all generation levels were used to create fish habitat below Table Rock Dam. Boulders measured approximately three to six feet in diameter and were placed in the lake using a 200 class, 45,000 pound excavator (Figure 3.2). Boulders were delivered to areas near the shoreline to reduce the amount of in-stream travel by the excavator. The materials were also transported and organized by a 605 class dozer outside of the water line, when possible (Figure 3.2).

Figure 3.2: Machines used for Lake Taneycomo habitat project.

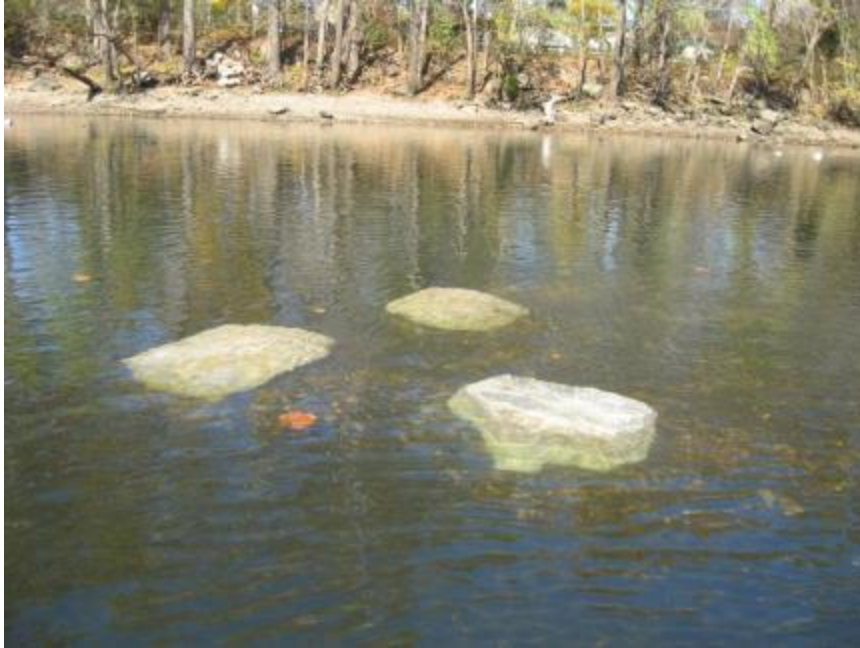
Boulder complexes were composed of three to five boulders for each structure (Figure 3.3) and varied in design based on environmental conditions and placement locations.

Figure 3.3: Lake Taneycomo habitat boulder cluster.

A variety of depths and areas were utilized for placement of structures. Some boulder complexes were concentrated in the thalweg portion of the channel in order to create scours and restore areas that had been filled in with gravel over time. Other boulder complexes were placed along the wetted perimeter at zero units of generation in order to create fishable habitat during periods of zero to two units of generation. Areas of loosely compacted gravel were given preference for placement of the boulders, allowing the increased velocity to more effectively scour and increase water depth.

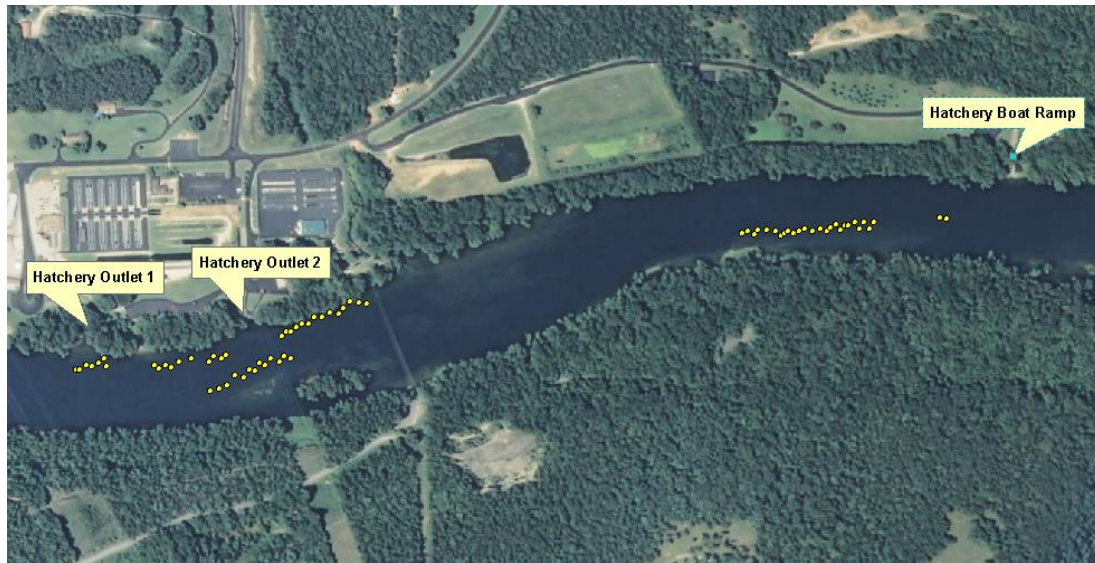
Figure 3.4: Lake Taneycomo habitat locations (GPS).

Additionally, structures were placed a minimum of 30 feet apart to ensure boating safety (Figure 3.4). Signs warning boaters of new habitat structures and boating hazards were also posted at boat ramps lakewide (Figure 3.5)

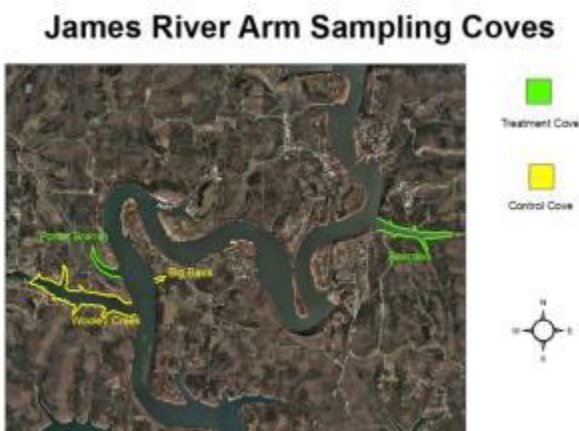
Figure 4.1: A map showing long-term electrofishing coves within the James River Arm of Table Rock Lake. Those selected to receive habitat treatments are shown in green whereas those serving as controls are outlined in yellow.

For this evaluation, a subset of all coves sampled as part of the long-term fish population monitoring program on Table Rock Lake were selected to receive treatments of shallow water habitat structures while others were designated as controls. Coves were selected in the James River ( $N = 4$ ; Figure 4.1), White River ( $N = 4$ ; Figure 4.2), Kings River ( $N = 6$ ; Figure 4.3), and Long Creek arms of the lake ( $N = 2$ ; Figure 4.4).

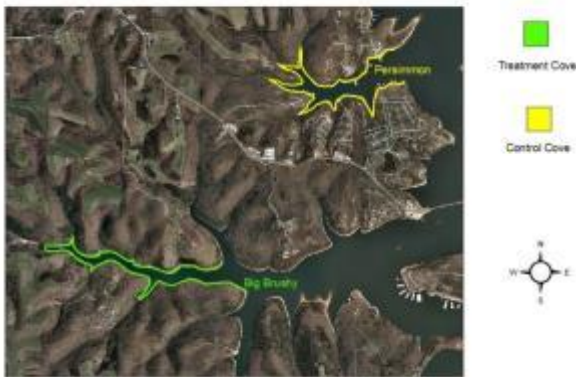
Figure 4.4: A map showing long-term electrofishing coves within the Long Creek Arm of Table Rock Lake. Those selected to receive habitat treatments are shown in red whereas those serving as controls are outlined in yellow.

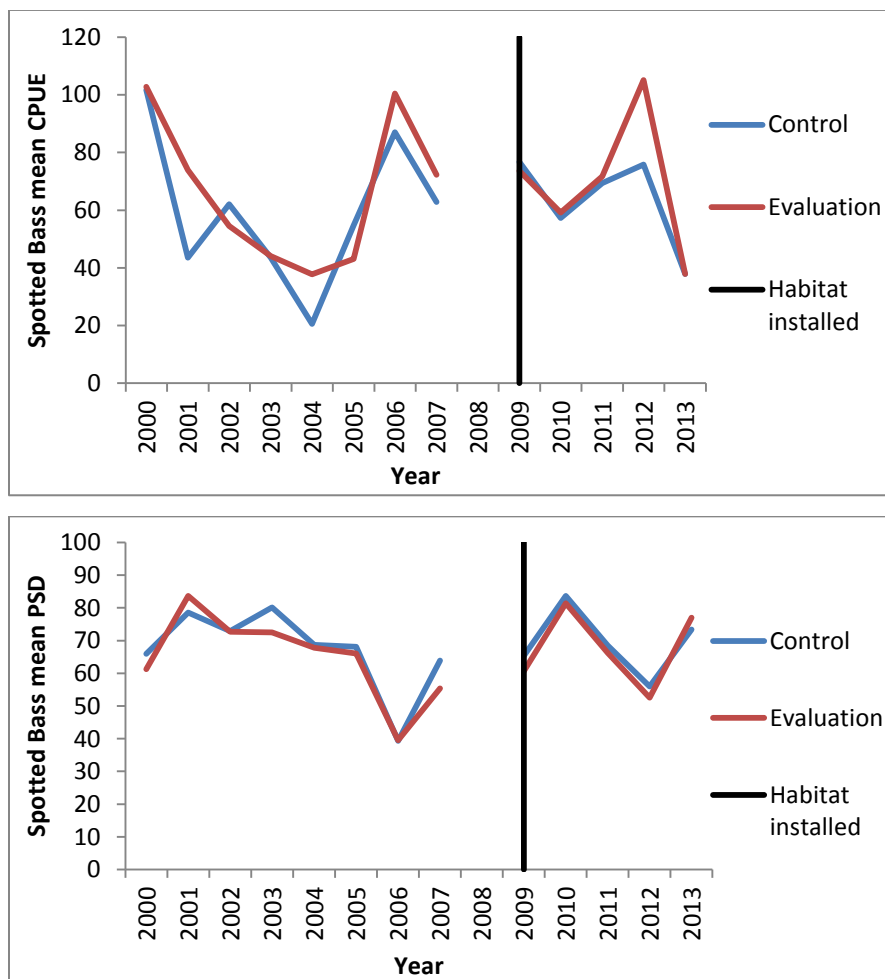
Figure 4.6: Data on catch per unit effort (CPUE), proportional size distribution of quality length (PSD) and preferred length (PSD-P) Spotted Bass were collected during annual electrofishing surveys on Table Rock Lake from 2000 to 2008 (pre-installation) and then from 2009 to 2013 (post-installation) in treatment and control coves.

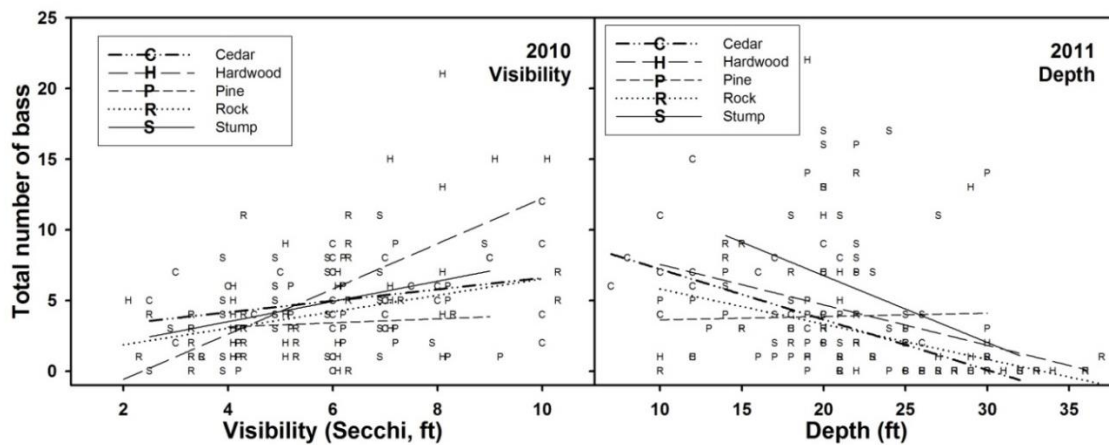
Figure 4.11: Scatterplots of structure visibility versus number (maximum between three and five minute observations) of total black bass observed, with points and lines by different structure types, during SCUBA evaluations conducted in 2010 and 2011.

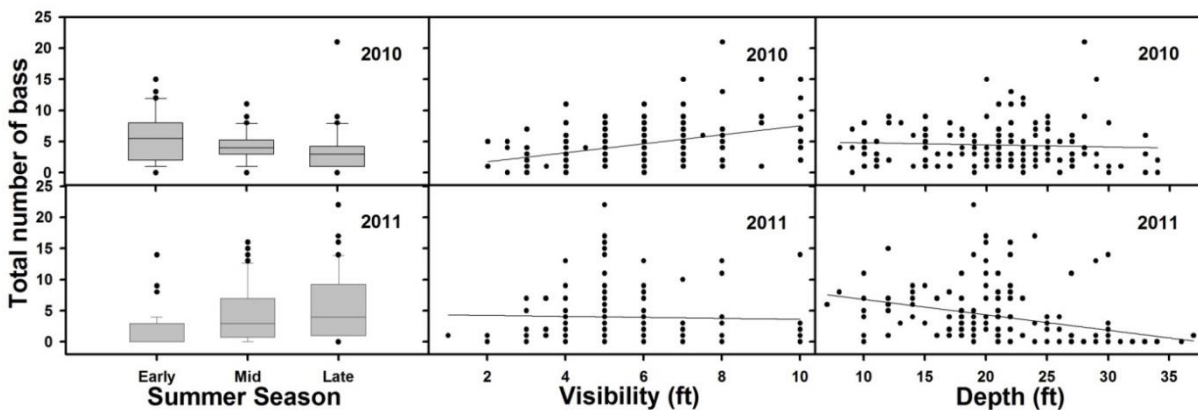
Figure 4.12: Relationship between number (maximum between three and five minute observations) of total black bass observed by summer season, structure visibility, and structure depth during 2010 and 2011.

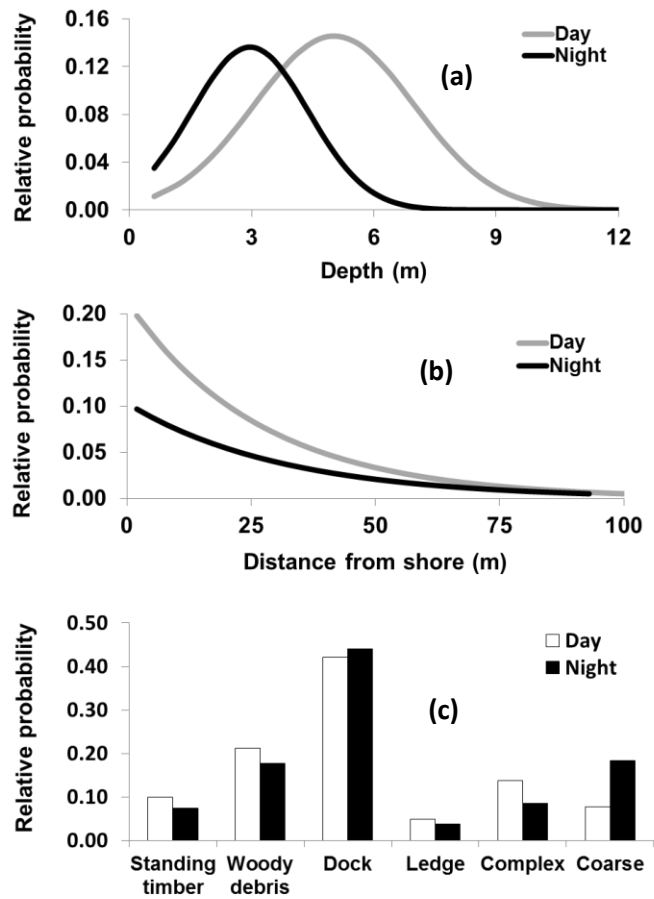
Figure 4.17 Results from our top model in the diel candidate set showing the relative probability (derived from parameter estimates and odds ratios) of Largemouth Bass selecting a specific depth (a), distance from shore (b), and structure (c), specifically standing timber, natural woody debris, boat docks, rock ledges, complex (evergreen and hardwood trees) and coarse (stump and rock piles) augmentation structure.

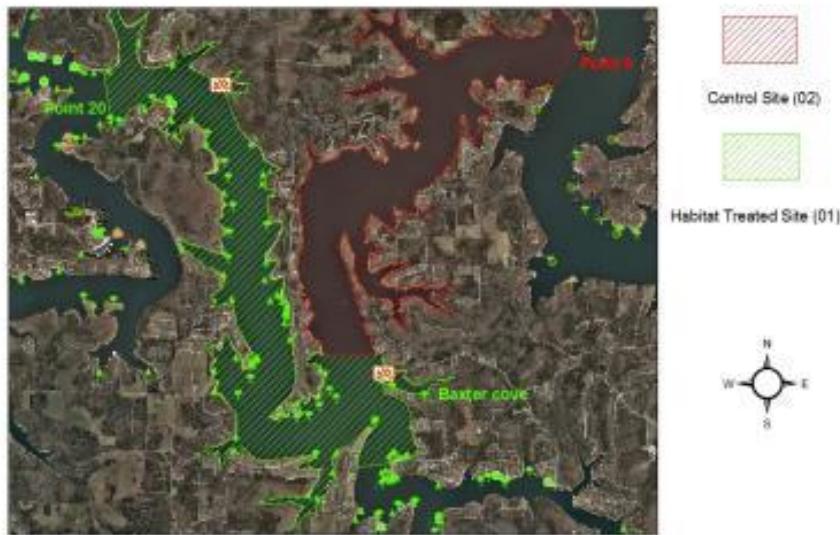
In the Mid-White Arm, Section 1 included the 1,692 acres between Baxter Cove and Point 20. Section 2 in the Mid-White Arm included the 2,140 acres between Point 9 and Baxter Cove (Figure 4.20).

Figure 4.20: Mid-White River Creel Zones
